Replacement of an Implant and Prosthesis in the Premaxilla Due to a Malposition and Prosthetic Failure: A Clinical Case Letter

Vito A. Cardo, Jr, DDS¹
Elliot Koschitzki, DDS^{2*}
Nachum Augenbaum, DDS²
Jenna L. Polinsky, DDS²

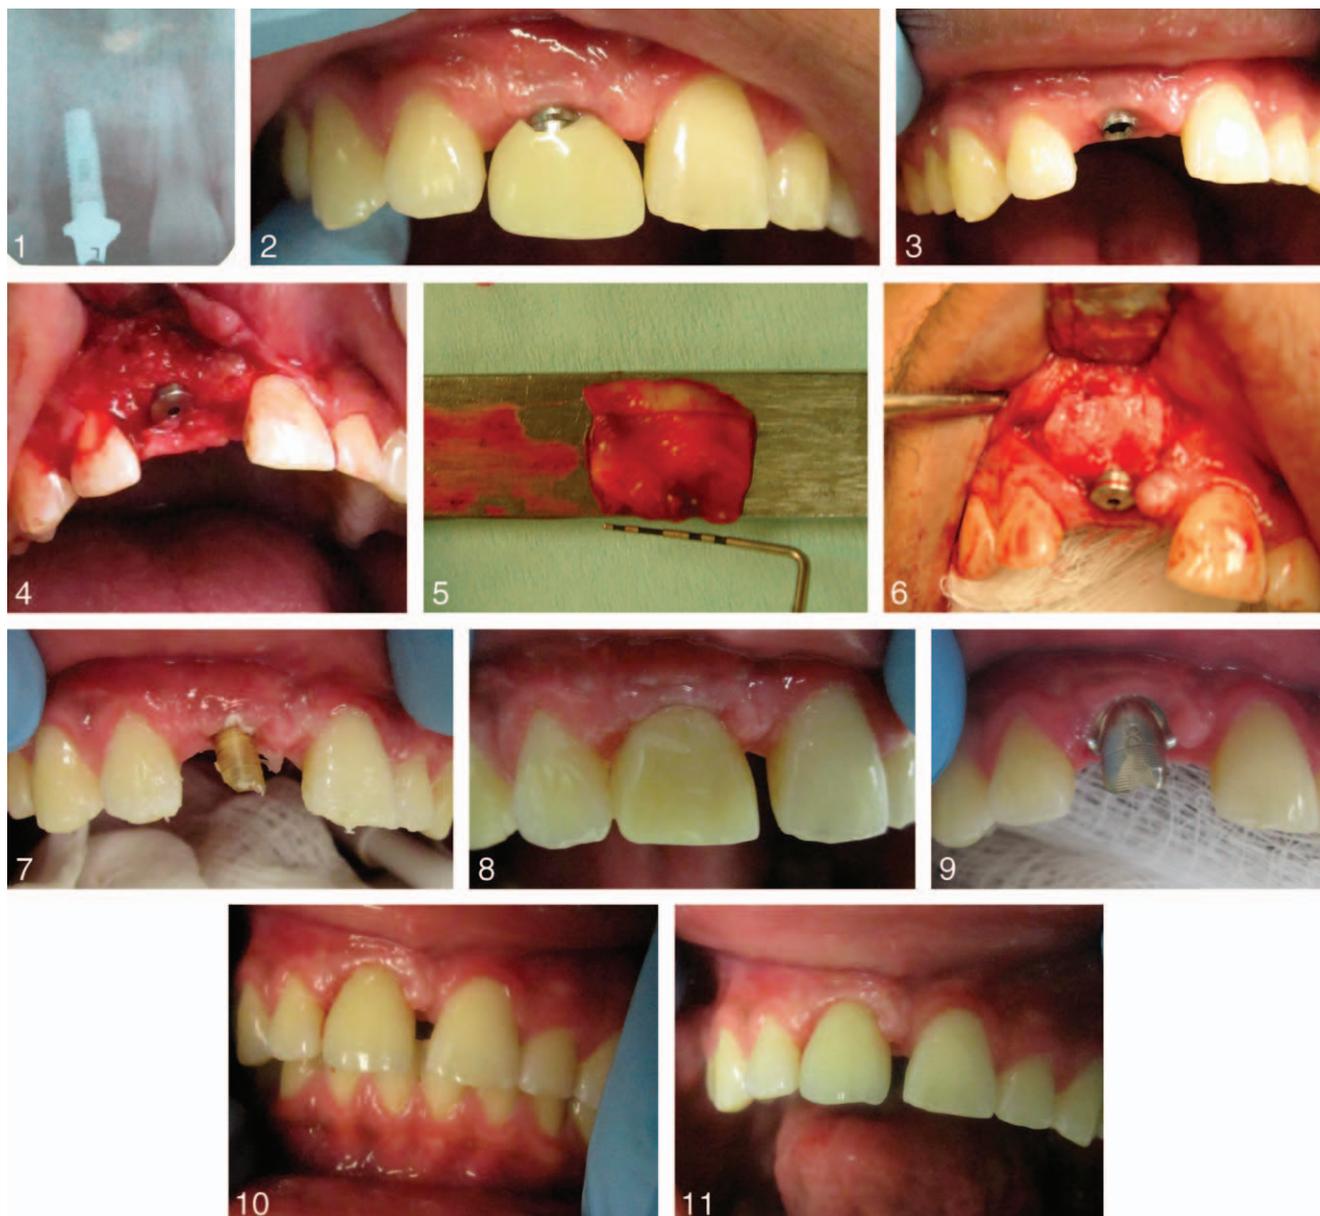
A 25-year-old male presented to the dental implant clinic at Brookdale University Hospital with a primary complaint of "my front tooth is too short and is chipped." Upon further discussion, the patient revealed that he had the implant placed 2 years prior, along with a bone graft. Radiographs revealed an endosseous implant tooth #8 with >50% bone loss (Figure 1). Intraoral examination showed a chipped porcelain fused to metal crown that is aesthetically unpleasing. The #8 crown is mesiodistally wider than #9 in an apparent attempt to close the diastema space. In addition, the crown exhibits a very poor emergence profile, with a short clinical height (Figure 2). Removal of the crown and abutment showed an implant platform in a supergingival position (Figure 3). Probing depths were 8–9 mm circumferentially. The patient denies pain or discomfort.

In the present case, the previous implant position in the apical–coronal direction was the direct cause for failure of both the implant itself and its esthetics. Removal of the implant was deemed necessary to achieve an optimal result. Placement of the new implant and crown helped to restore the patient to proper aesthetics and complete patient satisfaction. The apical–coronal position of the implant should be 2–4 mm apical to the expected gingival margin position.⁹ To prevent recession and improve esthetics, there should be 1–2 mm of facial bone. The new implant was placed 3 mm below the free gingival margin and followed an imaginary line that touched the incisal edges of the adjacent teeth. Grafting an area that is deficient in height is only as predictable as the height of the interdental bone of the adjacent teeth.

After obtaining a radiograph from the prior dentist, it was apparent that there was an attempt to graft the exposed threads above the crest at the time of implant placement. As seen in this radiograph, the graft was unsuccessful because the interdental bone was inferior to the implant platform.

FIGURES 1–11. **FIGURE 1.** Radiograph demonstrating 50% bone loss around implant. **FIGURE 2.** Poor emergence profiles of crown, short clinical height. **FIGURE 3.** Supergingival position of implant. **FIGURE 4.** Bone graft to implant site #8. **FIGURE 5.** Connective tissue harvested from palate. **FIGURE 6.** Connective tissue sutured to recipient site. **FIGURE 7.** Plastic coping prepped for temporary. **FIGURE 8.** Temporary in place. **FIGURE 9.** Custom abutment in place. **FIGURE 10.** Final prosthesis in occlusion. **FIGURE 11.** Final prosthesis.

It was determined that the implant was non-restorable and thus required extraction, bone graft, a new implant, and a new restoration. The patient agreed and gave both verbal and written consent. The patient was premedicated with 2 g of amoxicillin and 0.12% chlorhexidine rinse (Xttrium Labs, Chicago, Ill). Adequate local anesthesia of the site was obtained using 2% lidocaine with 1:100 000 epinephrine (Darby Dental, Jericho, NY). The implant was carefully removed using the counter-torque ratchet technique.⁷ After determining that the site had enough available bone for an immediate implant, a new osteotomy was prepared, and a 4.2 × 13-mm MIS "Seven" implant (Shlomi Industrial Park, Shlomi, Israel) was threaded into a position 3 mm below the facial CEJ of #9. The implant was buried, a MinerOss corticocancellous allograft bone (BioHorizons, Birmingham, Ala) was placed on the buccal defect (Figure 4), and the site was covered with a Mem-Lok resorbable membrane (BioHorizons). Primary closure was then obtained, and an Essex type appliance was delivered to the patient.

After 3 months of healing, a subepithelial connective tissue graft was harvested from the left posterior palate (Figure 5). A split thickness flap was raised around the #8 implant site, and the connective tissue (CT) graft was sutured to the periosteum (Figure 6). The healing abutment was replaced with a transmucosal stock abutment. Healing was uneventful.

Three months post-CT grafting, an immediate temporary was fabricated on an MIS plastic cylinder as described by Babbush et al.⁸ (Figure 7). Sculpting of soft tissue was accomplished over a 2-month period by carefully modifying the acrylic on the temporary (Figure 8). The soft tissue-free gingival margin was pushed apically to match the adjacent central incisor. When soft tissue contouring was completed, an open tray final impression was done and an Atlantis abutment (Astra Tech Inc, Waltham, Mass) (Figure 9) and an IPS e.max crown (Ivoclar Vivadent, Amherst, New York) were ordered from the lab. The lab was told to leave the diastema in place and contour to match #9. The crown and abutment were seated and cemented with Temp-Bond (Kerr Dental, Orange, Calif). The patient was satisfied with the aesthetics and function of the restoration (Figures 10 and 11).

presence of keratinized mucosa and the health of soft and hard tissues around implants. Therefore, based on this correlation, a subepithelial connective tissue graft was harvested from the palate and grafted to the #8 implant site.

temporary chairside, biweekly over a 2-month period. By adding a small amount of acrylic to the facial of the temporary, we were able to push the free gingival margin apically until we acquired our intended result (Figure 11).

For this case, we decided to use a CAD/CAM titanium milled abutment (Atlantis; Astra Tech Inc), as these abutments provide the most ideal emergence profile to support the peri-implant soft tissue contours. As the final restoration, we used an IPS

e.max crown (Ivoclar Vivadent) that is a lithium disilicate glass ceramic that provides optimal translucency, durability, and strength. The final restoration was evaluated on the working model for accuracy. Once proper fit and occlusion were established, the custom-fabricated abutment was placed on the implant fixture, secured, and torqued to 35 Ncm. Digital radiography was used to verify fit and integration. The e.max crown was tried in place and inspected for accuracy, contour, and shade match. Once the restoration was determined to be acceptable, it was cemented. A digital radiograph was taken to ensure no excess cement.
